Travers Ebling
Any St.
Santa Rosa, Ca.
95404

Basic Overview

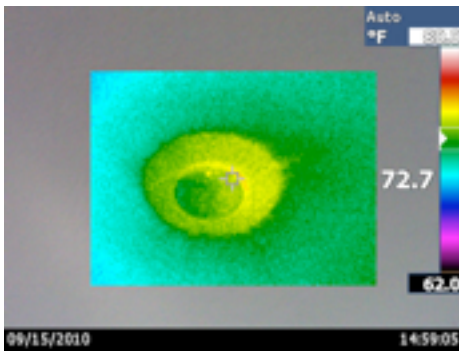
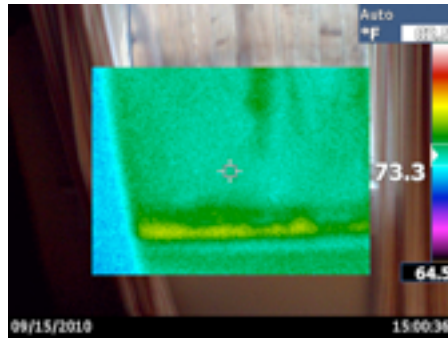
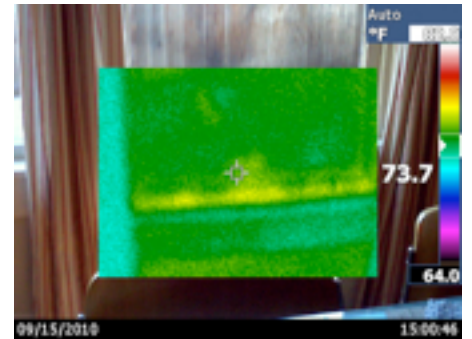
The camera revealed and confirmed areas of leakage in the house. The predominant leakage sources were the can lights through out the house and heat lamps in the bathrooms. A floor temperature gradient was examined between the master bedroom and the living room. This displayed a 3 degree difference, indicating a higher insulation value across the plywood subfloor in the master bedroom. The windows display nominal leakage at the sash and sill. The baseboards and the original wood flooring displayed leakage through cracks and seams between the joints.

The can light pulling air from the attic, and sash leakage in the dining room.

As per our discussions, Mr. Ebling came to the conclusion that the most imperative remediation is the sealing of the buildings envelope. We discussed what was the best option or area to start with. In my educated opinion it is the lighting. Recessed lighting that is insulation coverage rated (IC) is standard building code for the location of these lights. I recommend "airtight" models which are sold with a gasket which also seals the light to the drywall. This will prevent the infiltration of contaminants and slow the loss of BTU's across the envelope. This remediation will fulfill three functions: increase efficiency, increase the home's health, and the home's resale value. The efficiency will increase with the slowed stack effect which uses these air pathways to exhaust BTUs. The health will increase as the stack affect is slowed. The exhausting of air from the house requires make-up air. The make-up air, in this case pulled from the crawl space through the floor seams and baseboard cracks. With the stack affect halted, the house will no longer be infiltrating particulate and potential gases into the home. The resale value of the home will subsequently increase with the updating of the lighting systems in the home. This value is marketed both aesthetically, and through energy efficiency. I would recommend contacting SCEIP, as the data collected proves this level of remediation is an energy retrofit.

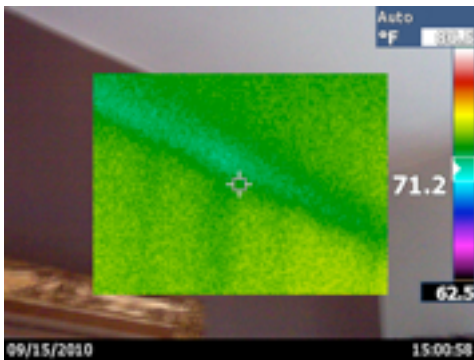
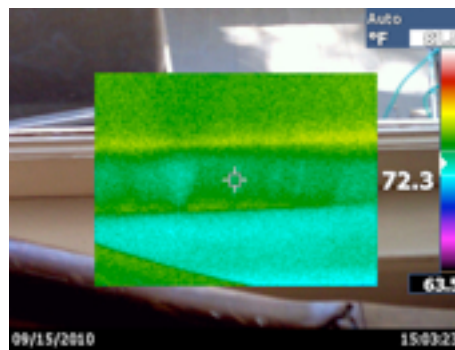
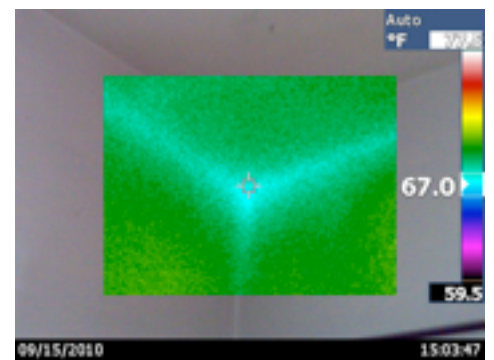
Leakage through the walls at plates, front window sash and corners.

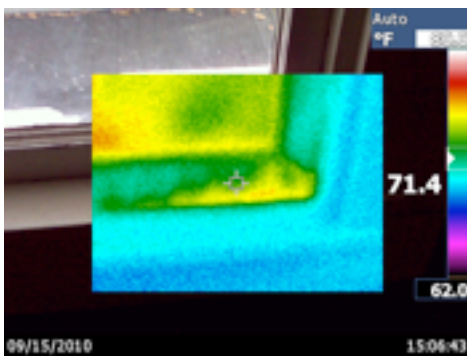
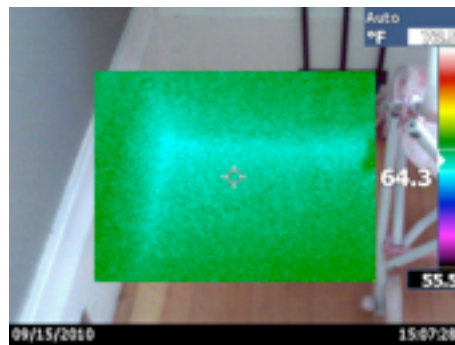
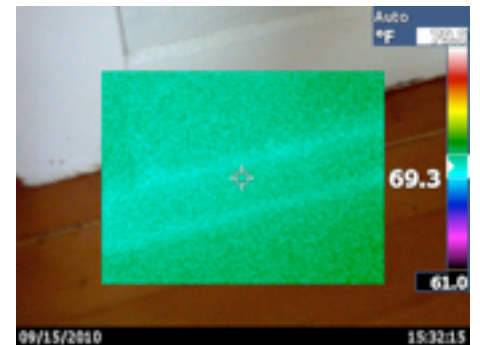
Leakage in sons room front window, along the baseboards, and cracks in floor.
